TS-1056	Universal Gripper Troubleshooting Guide	Document Owner: Service Department	Effective Date: JUL-14-2020	Page 1 of 5
---------	---	---------------------------------------	--------------------------------	-------------

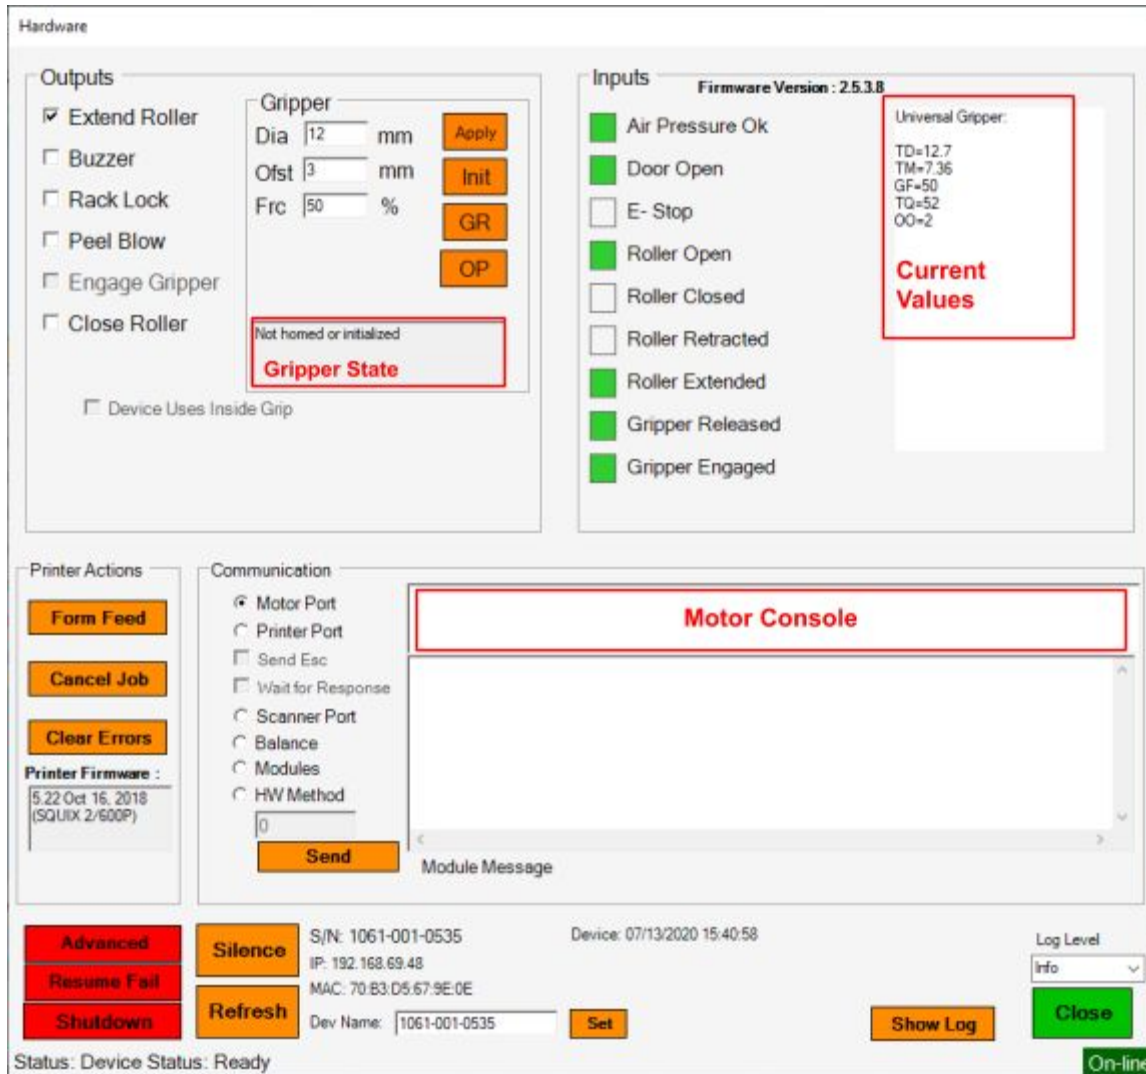
Figure 1.a

3. If the Status LED does not turn Red until motion has started, identify the error code above.
 - a. If the code is 1, the control board is likely damaged and needs to be replaced.

- b. For the other errors, check that all flex cables are properly seated in their sockets.
- c. If the motor sounds rough or loud, the motor cable is likely loose, or the control board is damaged and needs to be replaced.
